**Habitat Quality Index Assessment
Rangitata River
Arundel to Ealing**

Rangitata River Habitat Quality Index (HQI) Assessment

Arundel to Ealing

May 2020

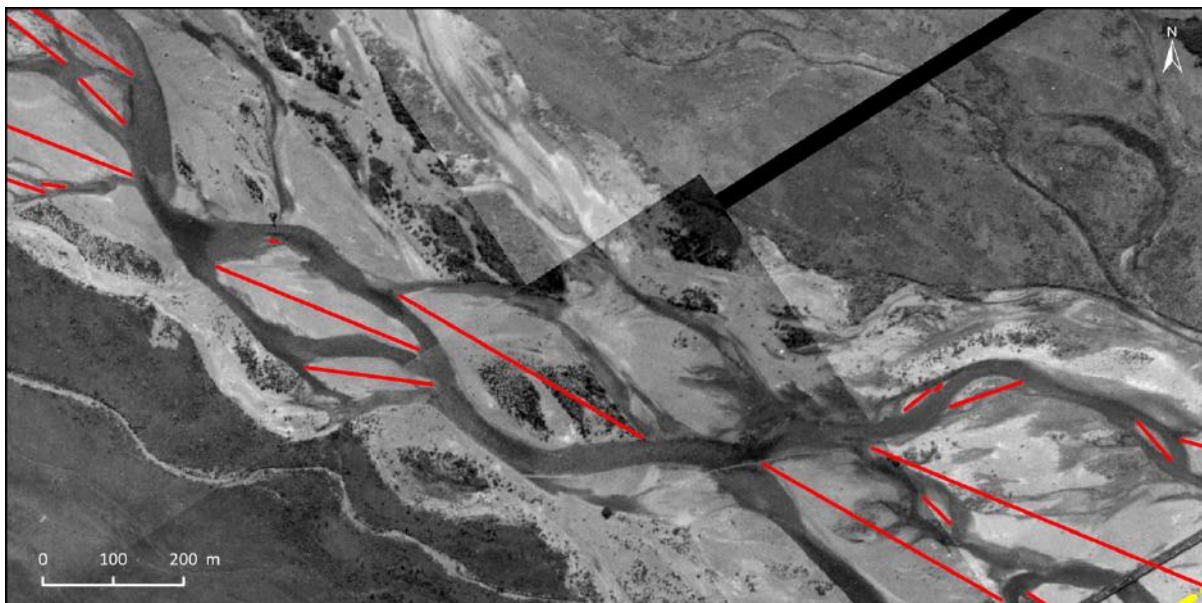
Figure 5: Lines drawn in ArcGIS Pro following the long axis of mid-channel bars in 1937. The total length of all lines in a reach was multiplied by two and then divided by the reach length to obtain a braiding index. The end of reach f can be seen at the bottom right of the image. Accurate assessment in some parts of the riverbed was difficult as a result of discontinuities (from the orthomosaic), lower resolution, and a lack of colour in the 1937 imagery, and over-exposure in some of the 2016-2018 imagery.

Braiding was assessed using Brice's Index, as defined in the work of Death et al. (in prep.), which states the extent of braiding is twice the total length of mid-channel bars in a reach divided by the mid-channel length of that reach. Bar length for each reach was measured in ArcGIS Pro using the line tool, multiplied by two, and then divided by the reach length as measured with the ruler tool. Given that the Rangitata River has many thalwegs, the mid-channel length was considered to be the length down the centre of the riverbed from the start to the end of each reach and was identical in 1937 and 2017/2018. An example of how braids were measured is illustrated in Figure 5.

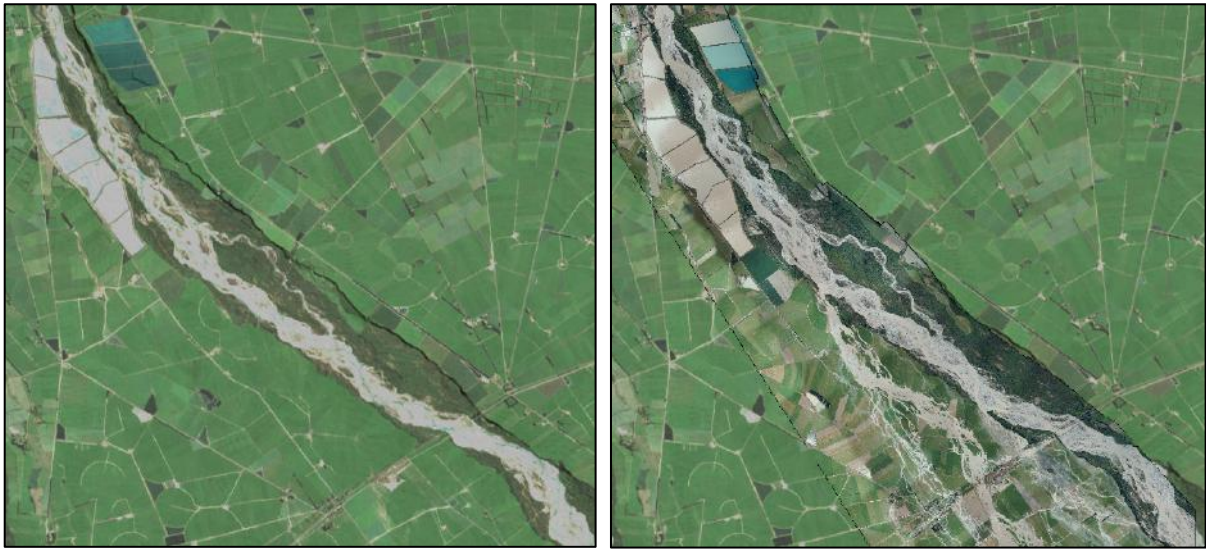
Figure 6: Rangitata River from Arundel to Ealing before (left) and during (right) flooding on the 9th of December 2019. Note the 'reclamation' of the south branch of the river. (ECan, n.d.).

8. Flooding in December 2018 illustrated the impacts of these changes when the river temporarily reclaimed previously flowing channels and again resembled its condition in 1937.

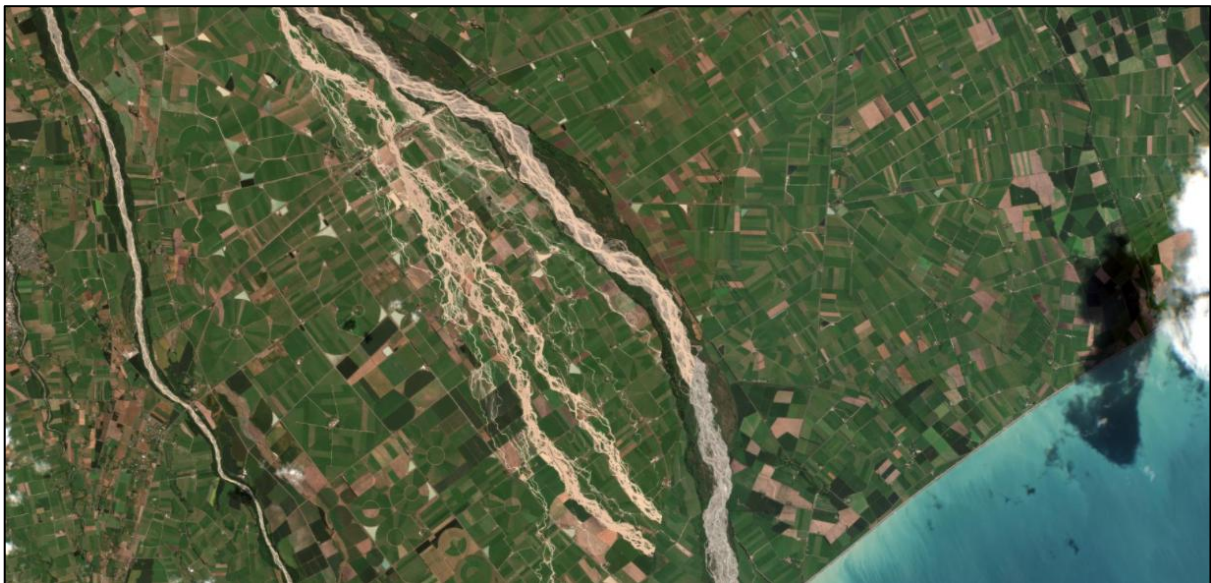
Figure 7: Orthomosaic image of the Rangitata River in flood, December 2019. Note the 'reclamation' of the south branch of the river.
